Common Problems & Solutions for Zirconia Restorations

■ Common Problems and Solutions for Zirconia Restorations

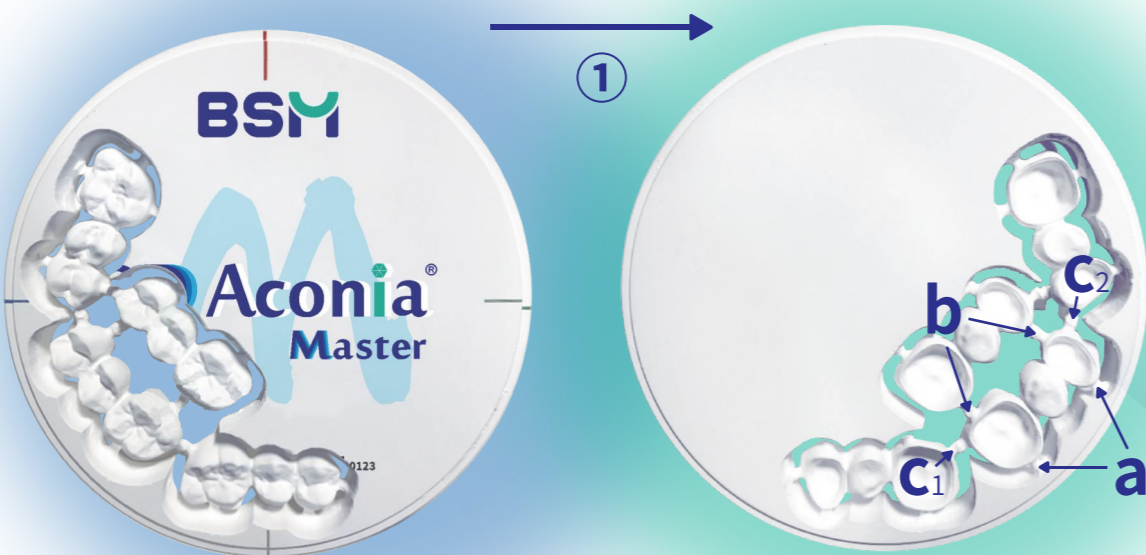
2. Chip or Fracture When Removing from Zirconia Disc

Possible Causes:

- Inadequate grinding device speed/improper tool placement
- Non-standard procedures causing micro-cracks

Solutions:

- Control grinding speed at **10,000–12,000 RPM**; position tools centrally.
- Follow manufacturer guidelines:
 - Remove connector bars incrementally (e.g., grind 50% first, then complete removal)①.
 - Maintain unidirectional motion (clockwise/counterclockwise).

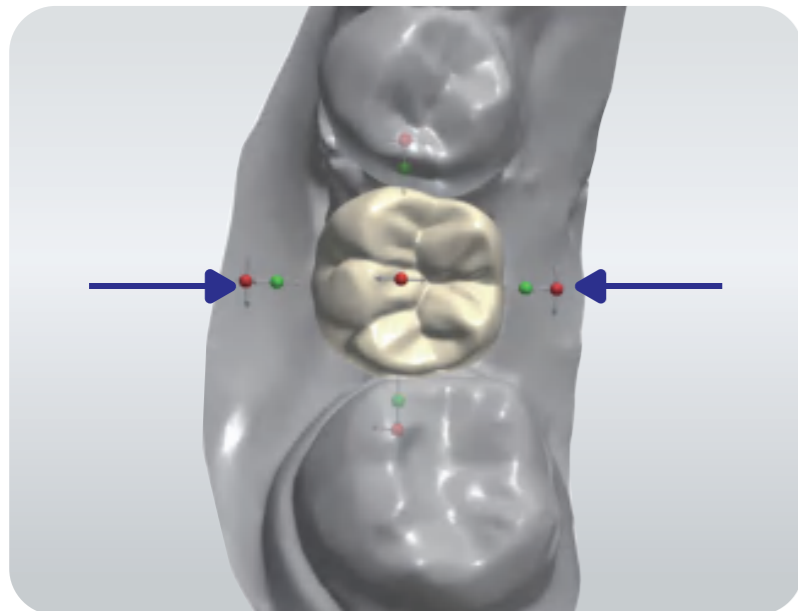
5. Intraoral Fracture During Placement

Possible Causes:

- Inadequate space/undercuts; sharp margins.
- Design flaws (e.g., insufficient cervical thickness, poor bridge contact).
- Undetected micro-cracks during restoration fabrication.

Solutions:

- Collaborate with dentists to adjust tooth preparation or opposing dentition.
- Ensure design parameters:
 - **Cervical thickness:** >0.3 mm
 - **Connector cross section area:**
 - Anterior: 7 mm² (two consecutive crowns), 9 mm² (3-unit), 12 mm² (long bridge)
 - Posterior: 9 mm² (two consecutive crowns), 12 mm² (3-unit), 16 mm² (long bridge)

Occlusal thickness: Maximize when possible; reduce buccolingually if needed.

Implant hole position: Centralize on occlusal surface, avoid edges.
